SPECIAL OPERATION REPORT

General information				
Location	WOODROCK		Specific area or site	SANRAL RESERVE
Date of Operation	15 May 2020		Time Of Operation	10h00
Type of Operation	DRONE/K9 ComOp

Operation Objective

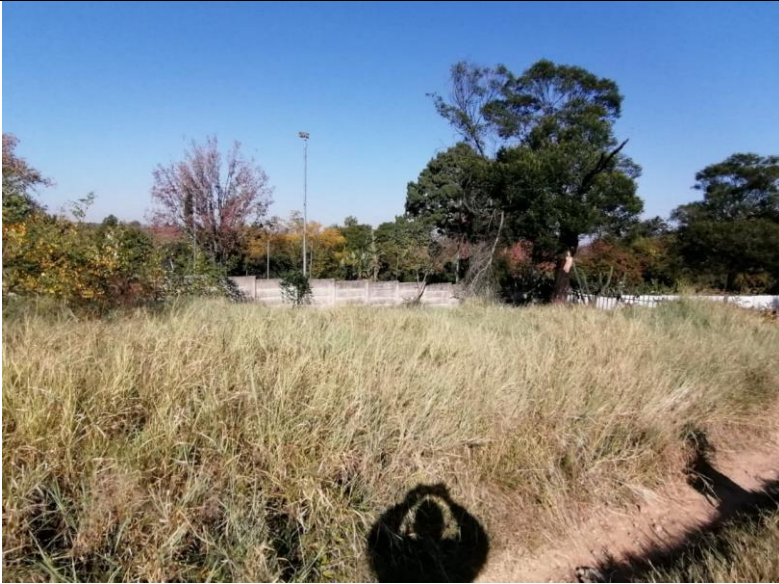
Fig 2: The first two properties on the Riley Road corner have no evident perimeter protection

- **Fig 2:** These properties need to be encouraged to install perimeter protection of some sort
- **Fig 3:** These young gum trees need to be cut out before they grow any more as they will damage and compromise the perimeter security along the

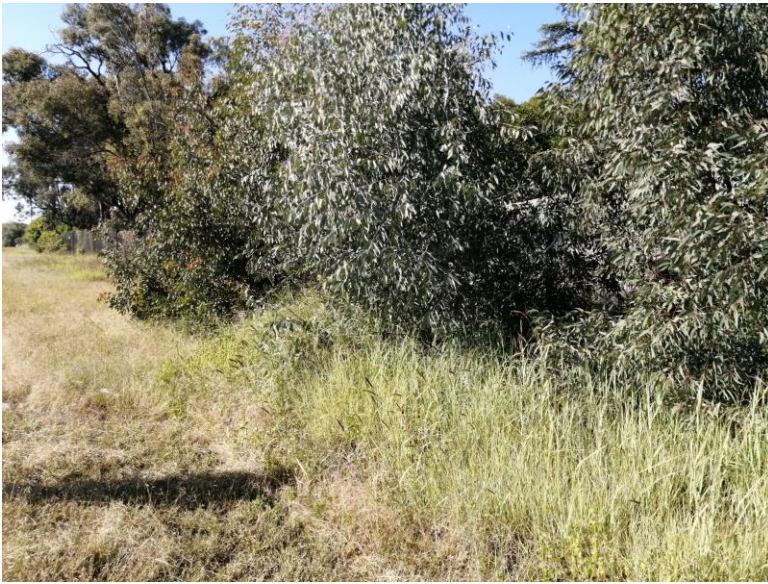
Fig 3: These young Gum trees on the perimeter fence need to be cut out before they get bigger

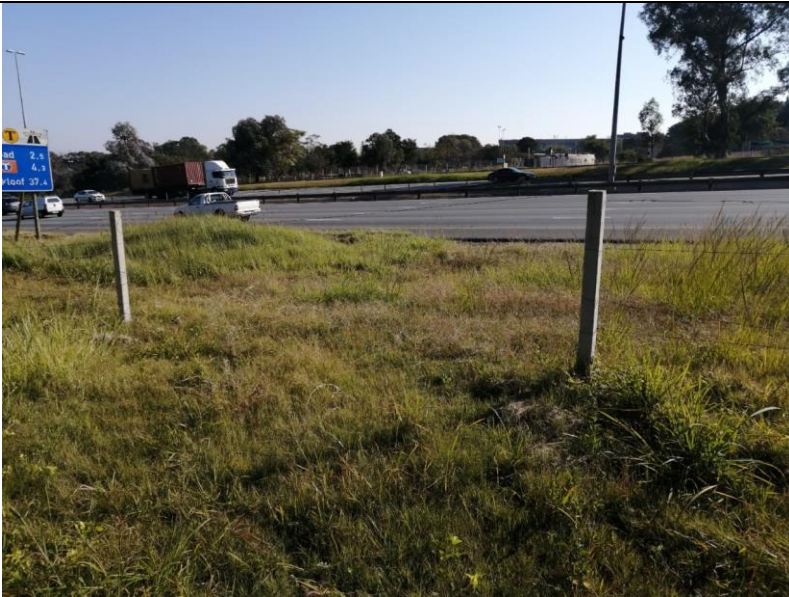
Fig 4: Fence cut along highway we understand it the for the people who cut the grass in the reserve.

- **Fig 4:** The barbed wire strands have been cut and I understand it was done by whomever maintains the SANRAL reserve as they have no other way of accessing the area to cut it. We need to find an alternative entry point that does not compromise the area's perimeter security like this..

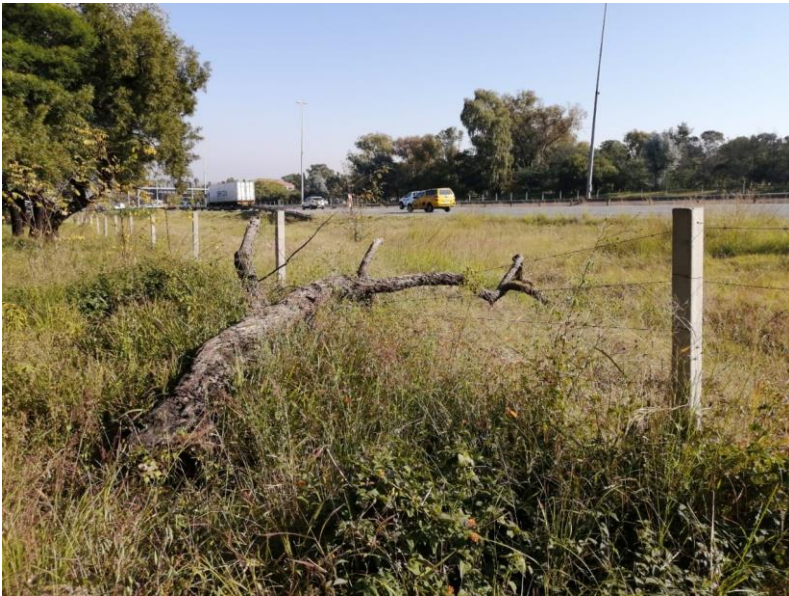
Fig 5: A tree has fallen on the perimeter fence creating an entry/exit point off the highway.

- **Fig 5:** There is a dead tree across a section of the barbed wire fencing, this tree needs to be cut up and the broken fencing reinstated.
- **Fig 6:** A further section of the perimeter fencing being compromised by overgrowth of vegetation, this all needs to be cut back and maintained regularly so as to not compromise the area's security.

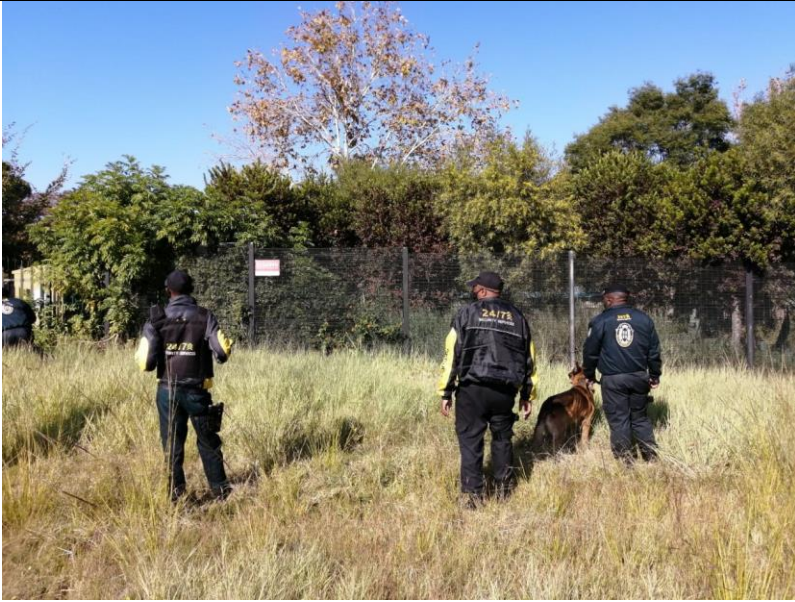
Fig 6: The perimeter compromised by overgrown foliage

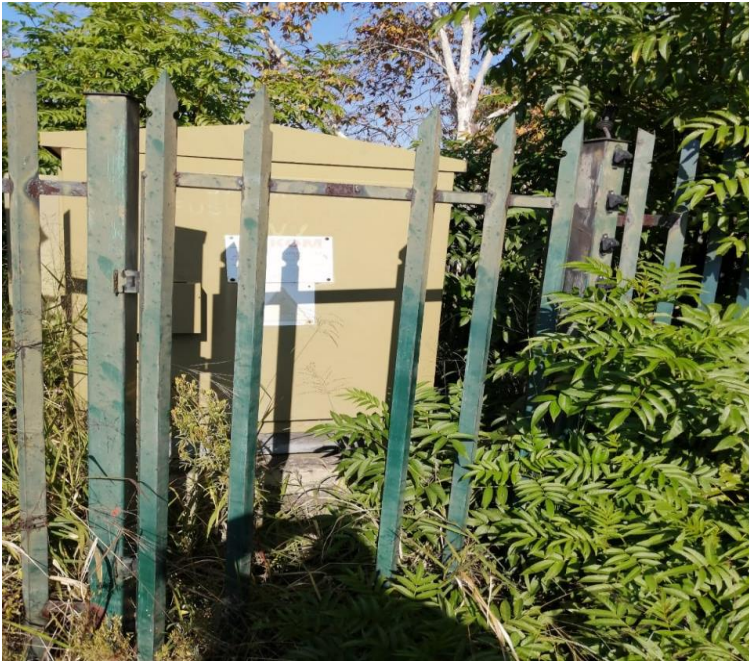
Fig 7: A missing palisade pole of the Eskom transformer providing an entry into Woodrock

- **Fig 7 & 8:** This is our biggest concern the missing palisade pole and padlock on the inside gate is free undetected access in and out of the area and needs to be addressed as a matter of urgency. We have put a temporary padlock on the gate.

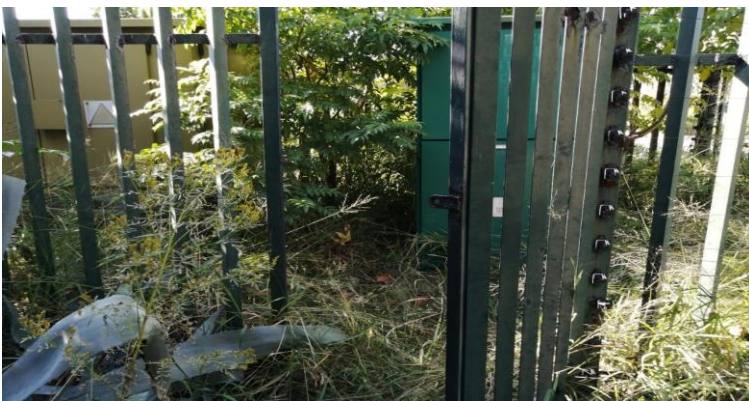
Fig 8: No Padlock on the inside gate of the Eskom Transformer

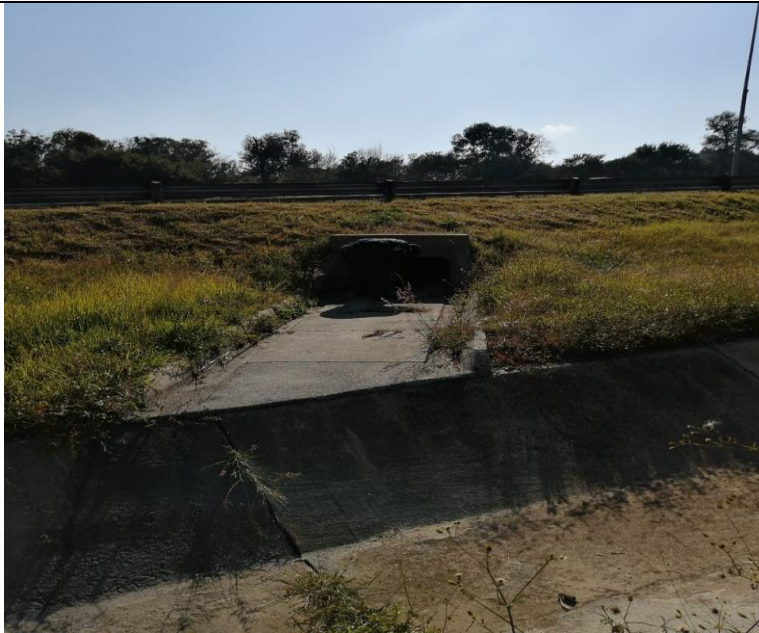
Fig 9: Storm drain tunnel connects Woodrock to the squatter camp across the highway

- **Fig 9:** This storm drain links the squatter camp across the road to the SANRAL reserve which is of great concern. I would suggest an engineer have a look at it and advise if there is anything that can be done to "human proof" the tunnel.
